ENVIRONMENTAL SITE INSPECTION

1. Business System Site Number: ML 50751
2. Lease/Site Manager: Will Stokes
3. What is the date of your inspection and who conducted the inspection? 3/23/11 by  
Sonja Wallace and Ron Barton

ML 50751, Grand County

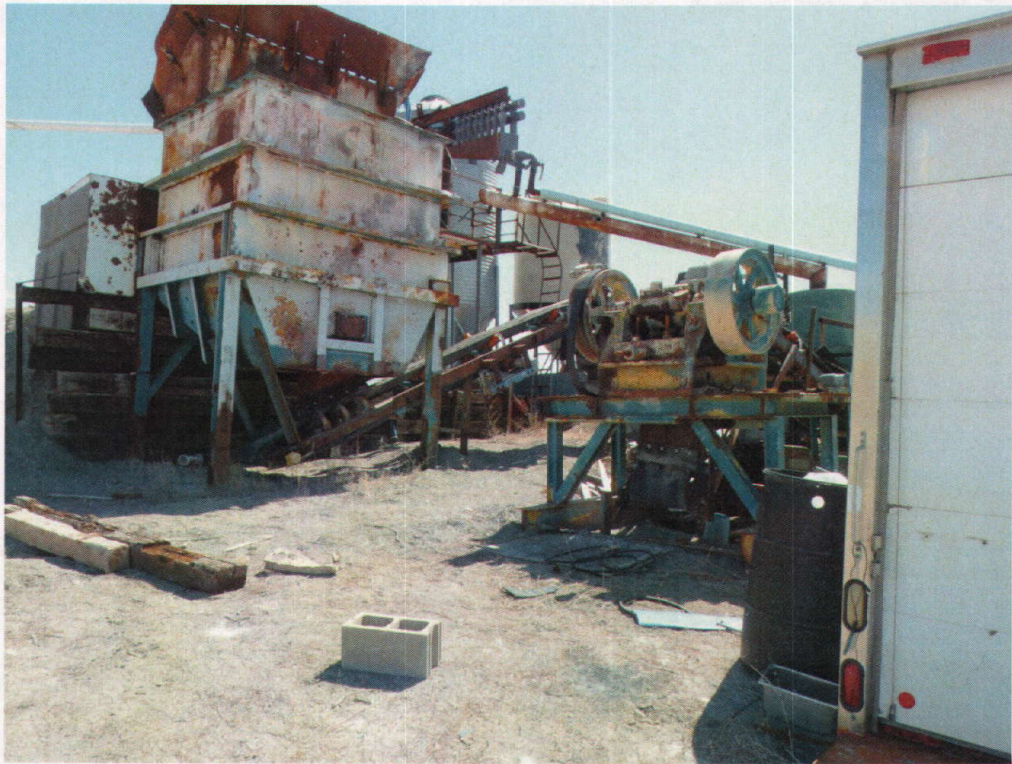
**Main Processing Equipment at Site**

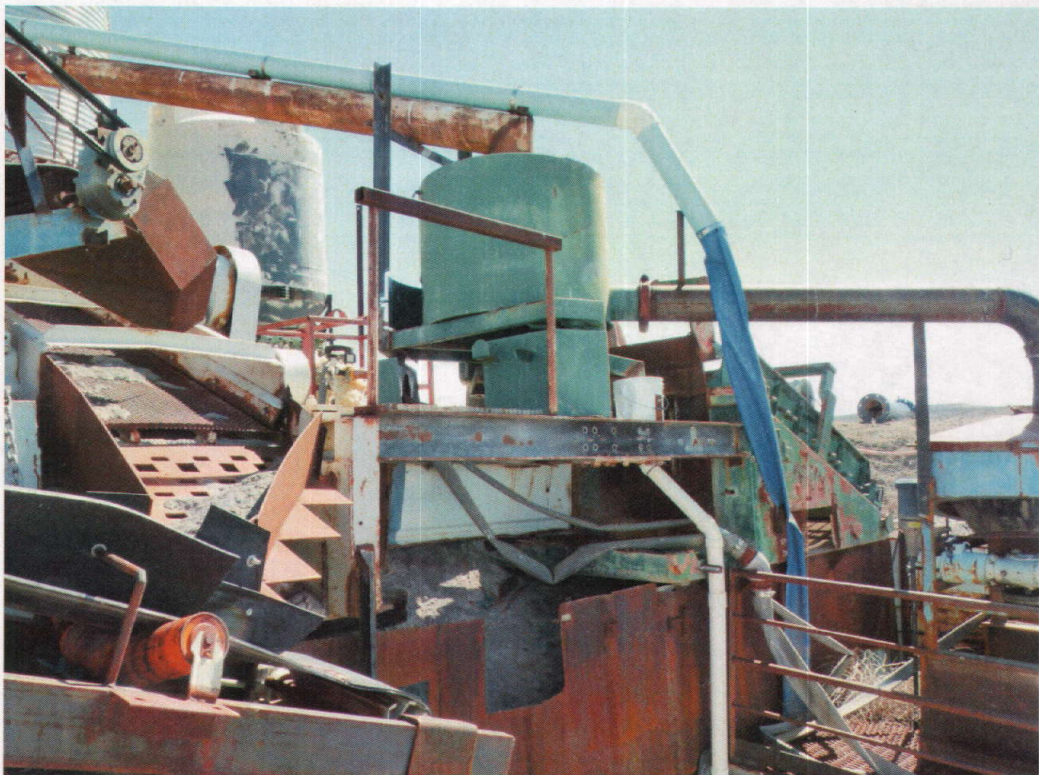
**Main Processing Equipment that Appears to be Neglected**

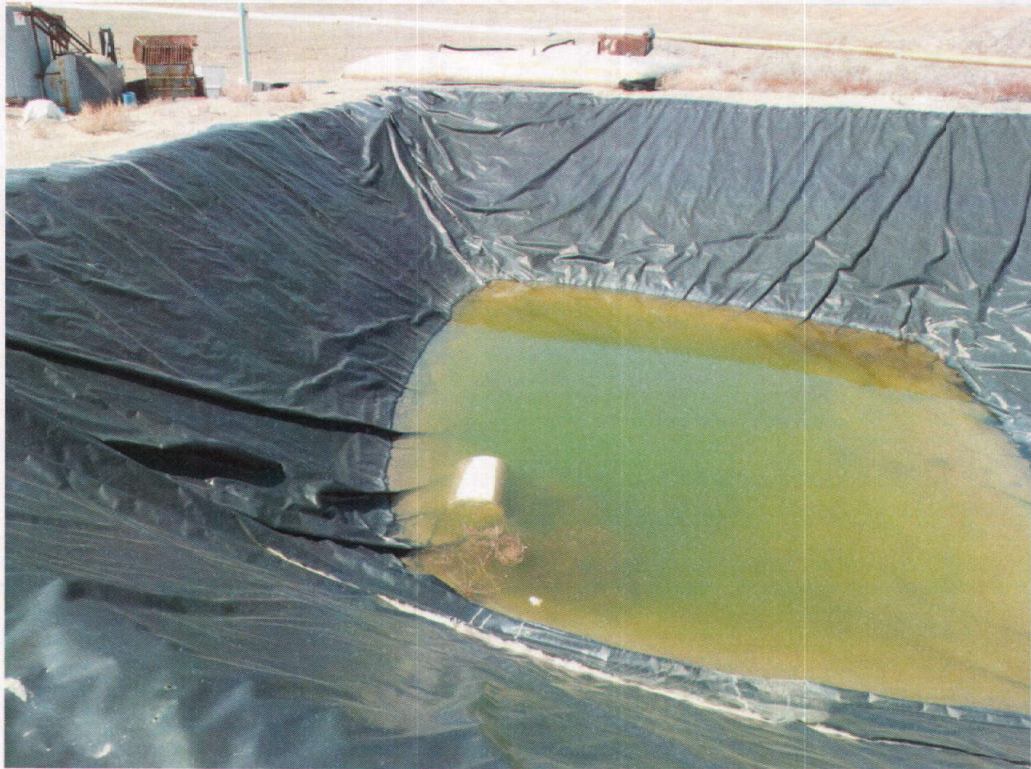
**Lined Containment Pond #1**

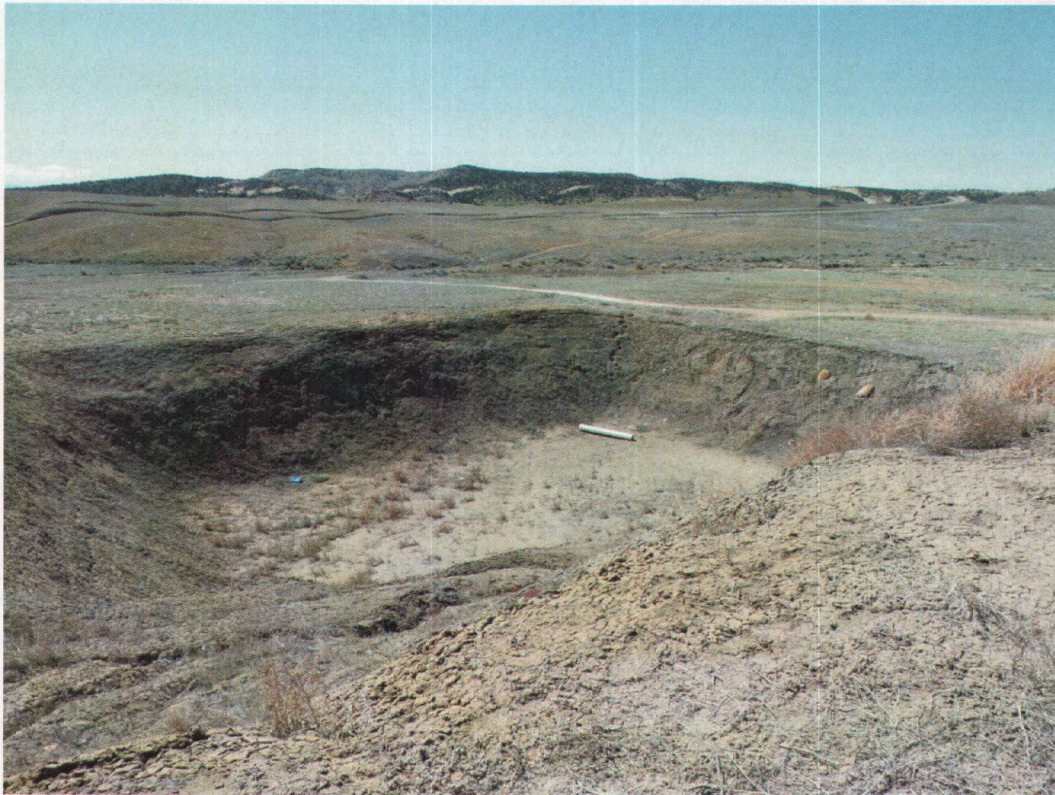
**Un-lined Containment Pond #2**

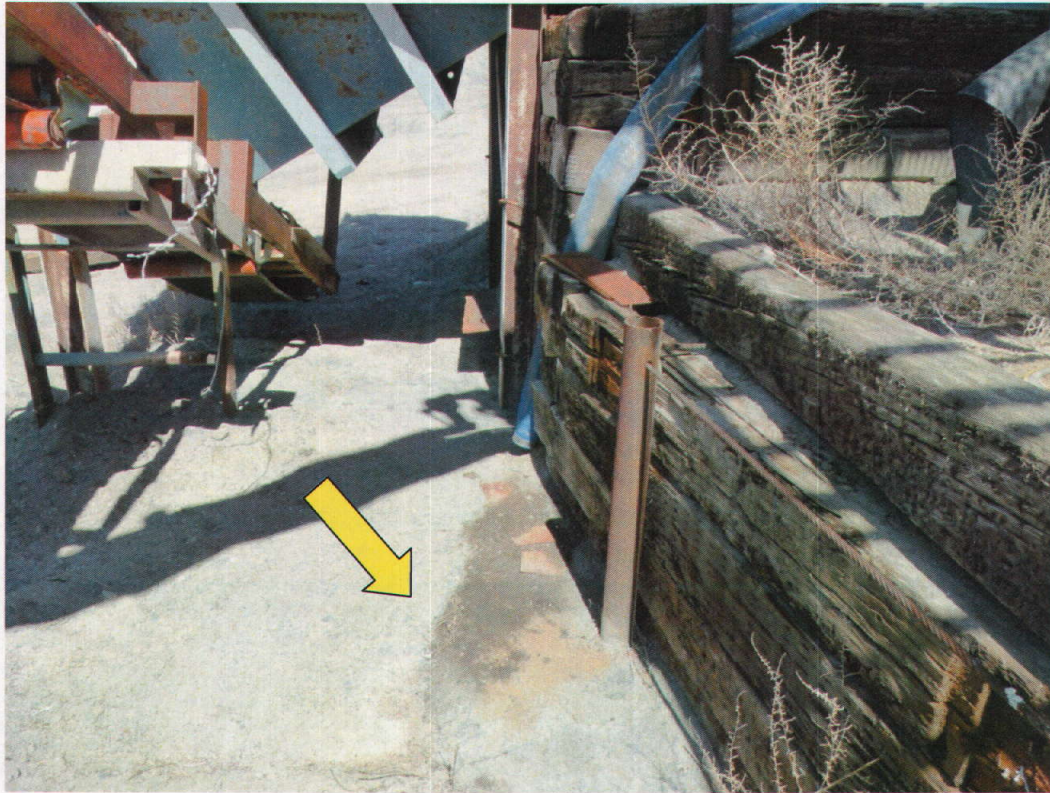
6. What are the approved uses at the Site? Humic Shale mining and processing facility.
7. Is there any staining on the surface at the Site? If yes, please describe or photograph  
Yes

**Surface Staining**

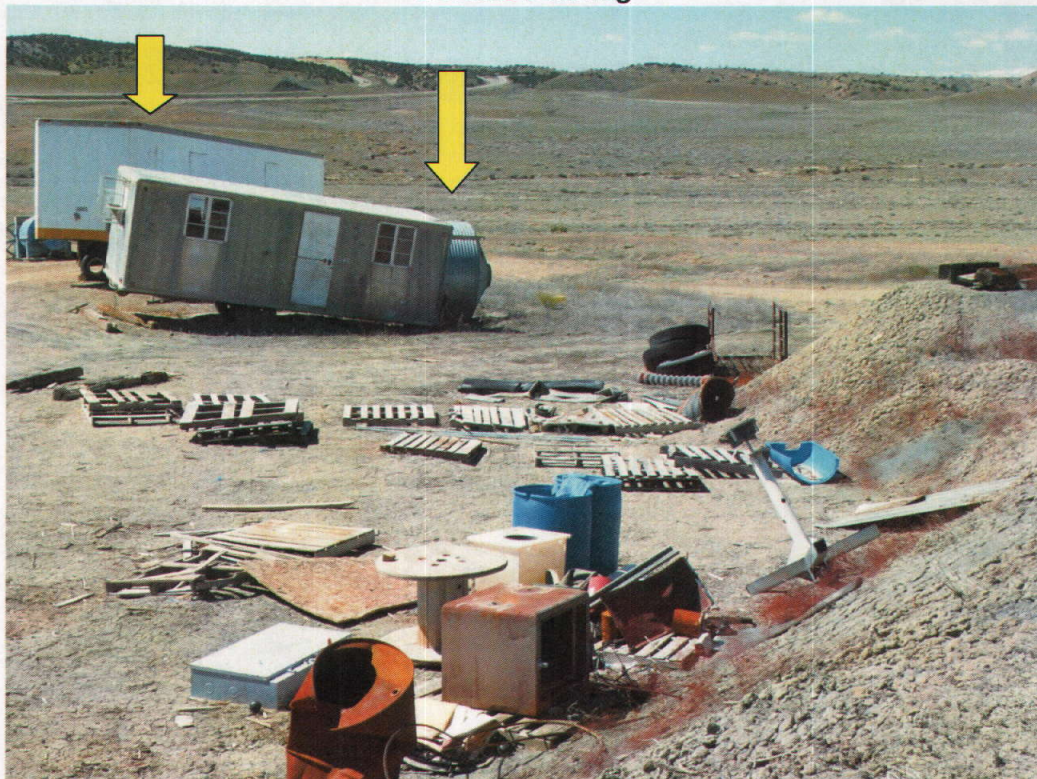
16. Are there Water Rights associated with this Site? If yes, please list: No
17. What recommendations do you have for work that needs to be completed at the Site? The site appears to have been abandoned or not in use for some time. There are 2 large trailers (1 is a semi) full of various un-labeled materials so there is no way to determine what hazardous they might contain. Most of the materials seem to be inert, but I am unsure of this. In the semi trailer, when the back door was opened, a distinct chemical smell was detected, indicating either leaking or improperly stored materials. It does appear that many of the materials have weathered and the containers/structures they are in, are now falling apart or rusting causing these materials to spill out, and in some cases, mix. There is a large secondary containment vessel that is  $\frac{3}{4}$  full of oils/greases that is not properly maintained.

**Misc. Surface Debris at Site. Arrows Indicate 2 Storage Trailers Loaded Full with Unknown materials and Chemicals.**

18. What Site improvements (if any) would you recommend? The site's housekeeping needs to be improved substantially. Materials need to be marked as to their contents, dated and properly segregated to reduce the potential reaction of chemicals. Trash from the site needs to be removed. Used oils/greases need to be removed and/or properly stored in a covered, cool area with proper containment and labeling. The Lessee should be notified of these problems and given a specific time frame to remedy these issues.

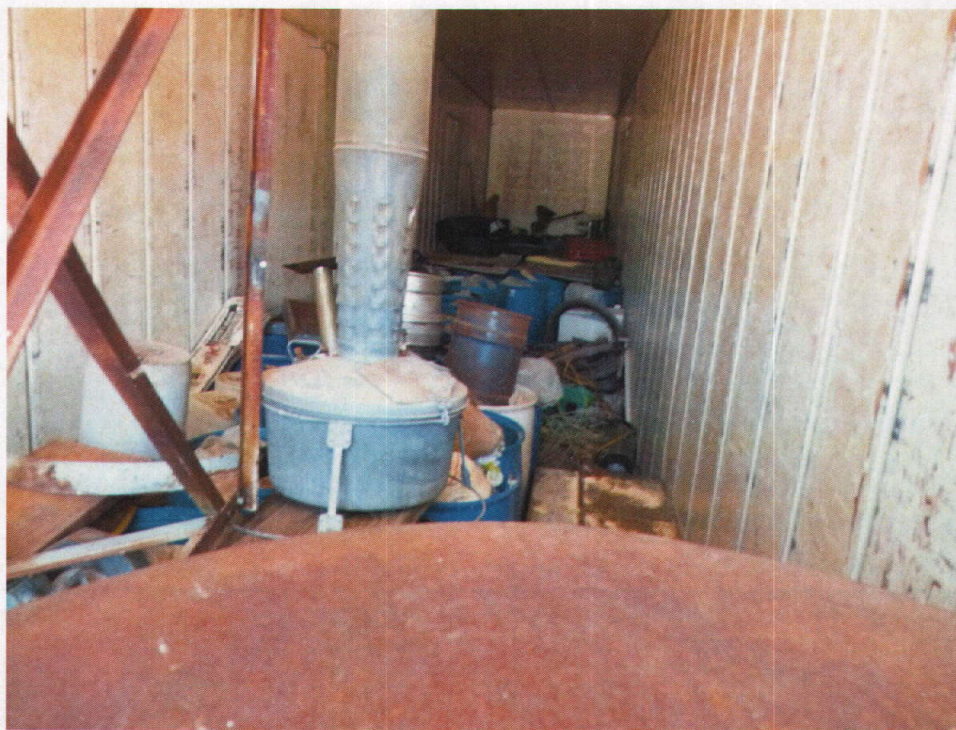
**View Inside Semi Trailer**

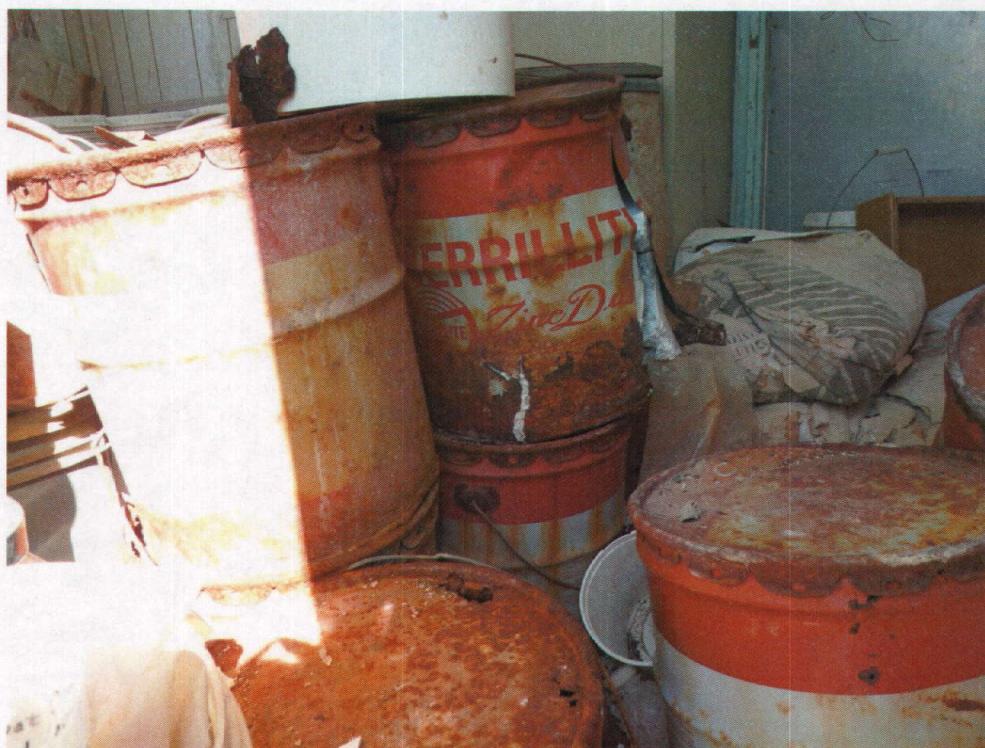
**View of Degraded Containers in Smaller Storage Trailer**

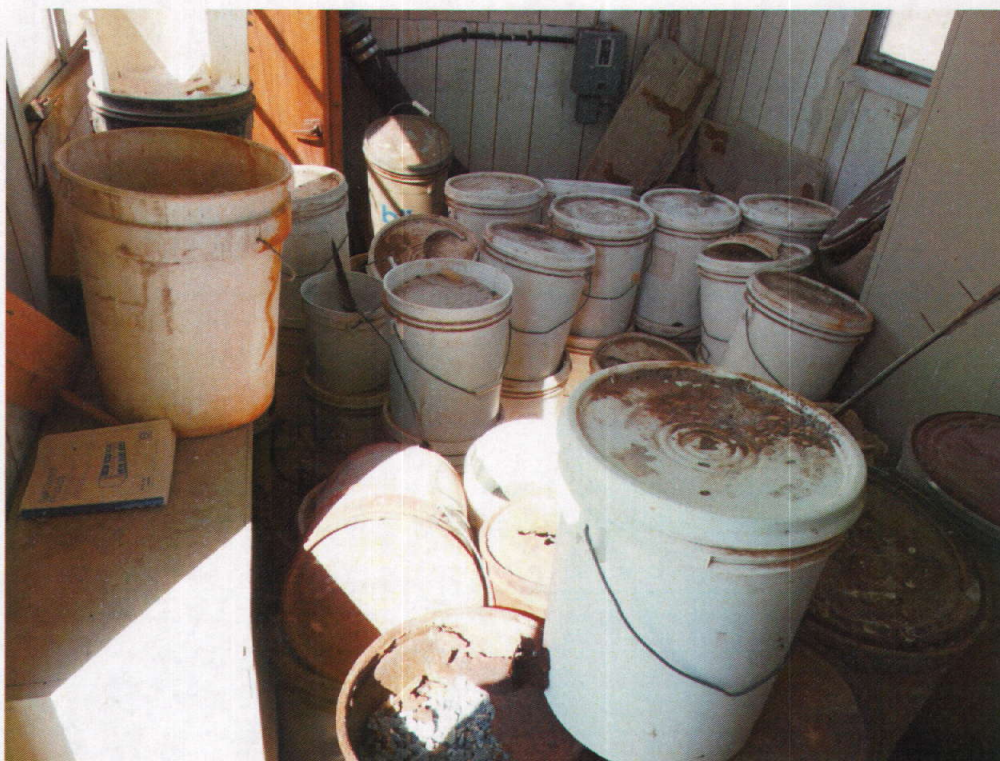
**Un-Labeled Containers, Small Trailer**

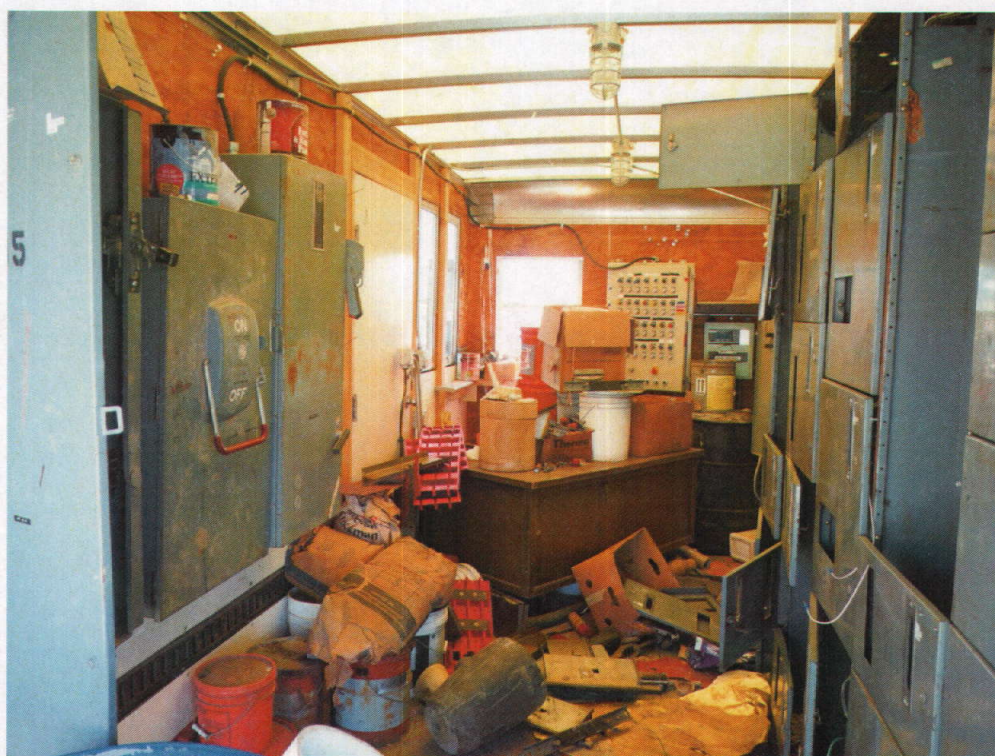
**Inside of Trailer Housing Equipment Control Panels**

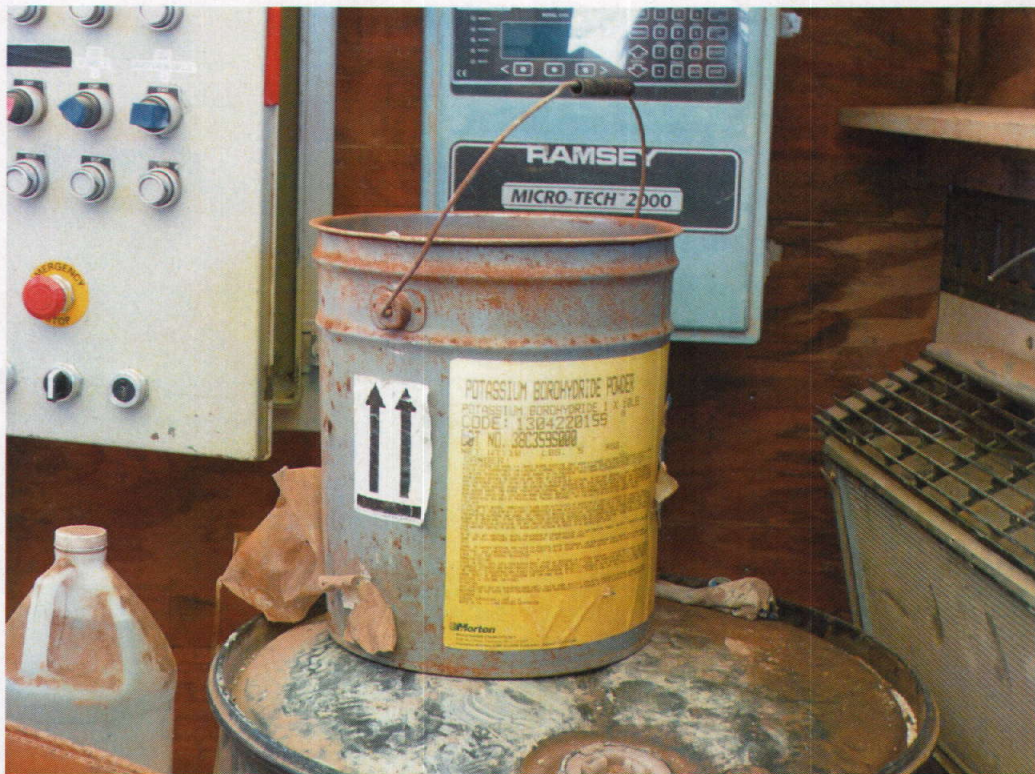
**Inside Control Panel Trailer. This Chemical, Potassium Borohydride, Reacts Violently with Water (Note Moisture on Top of Black 55 Gallon Drum)**

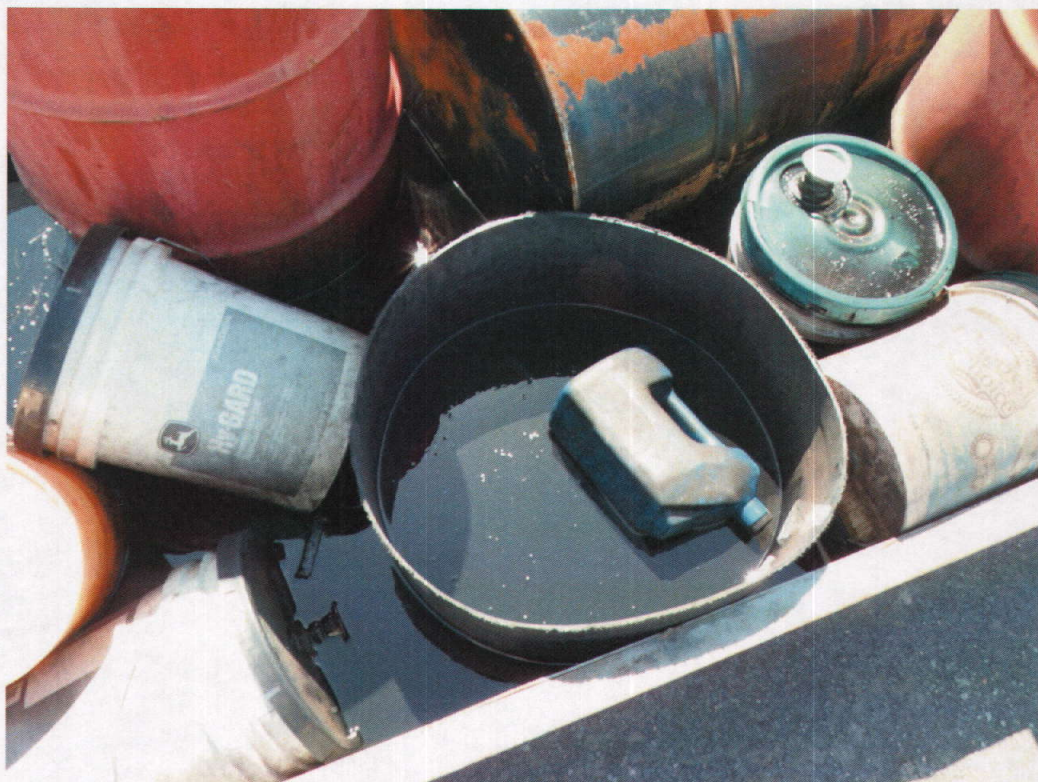
**Improper Storage of Used Oils/Greases**

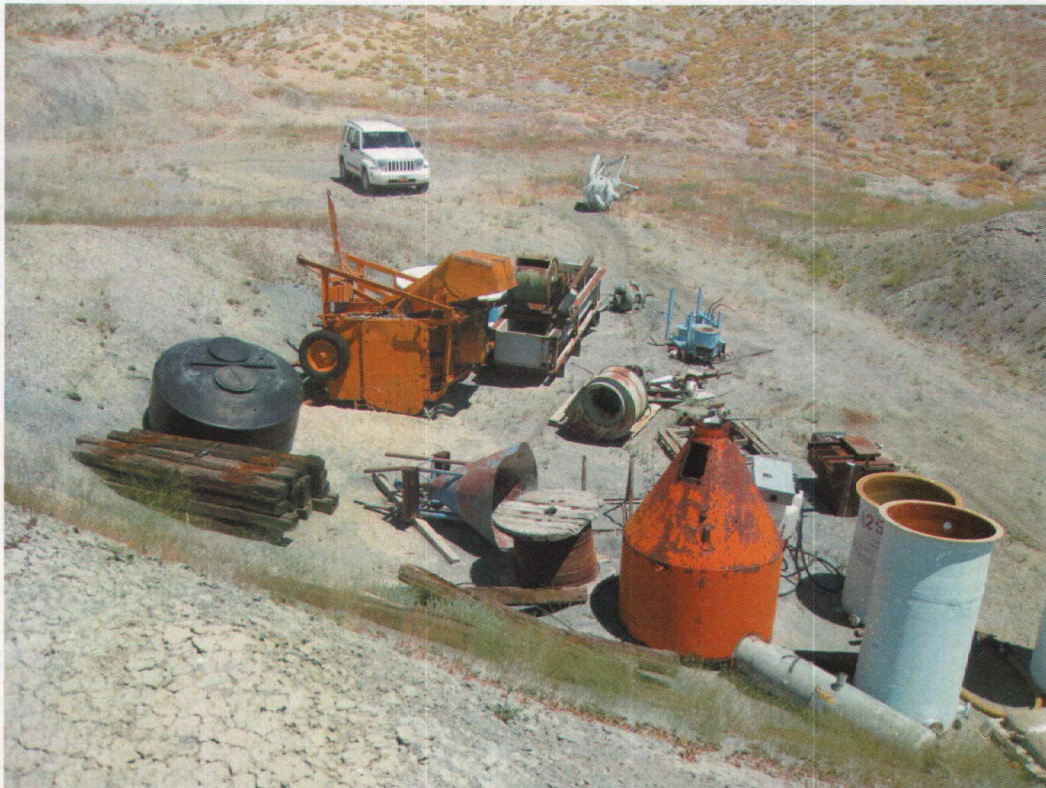
**Misc. Equipment at Site**

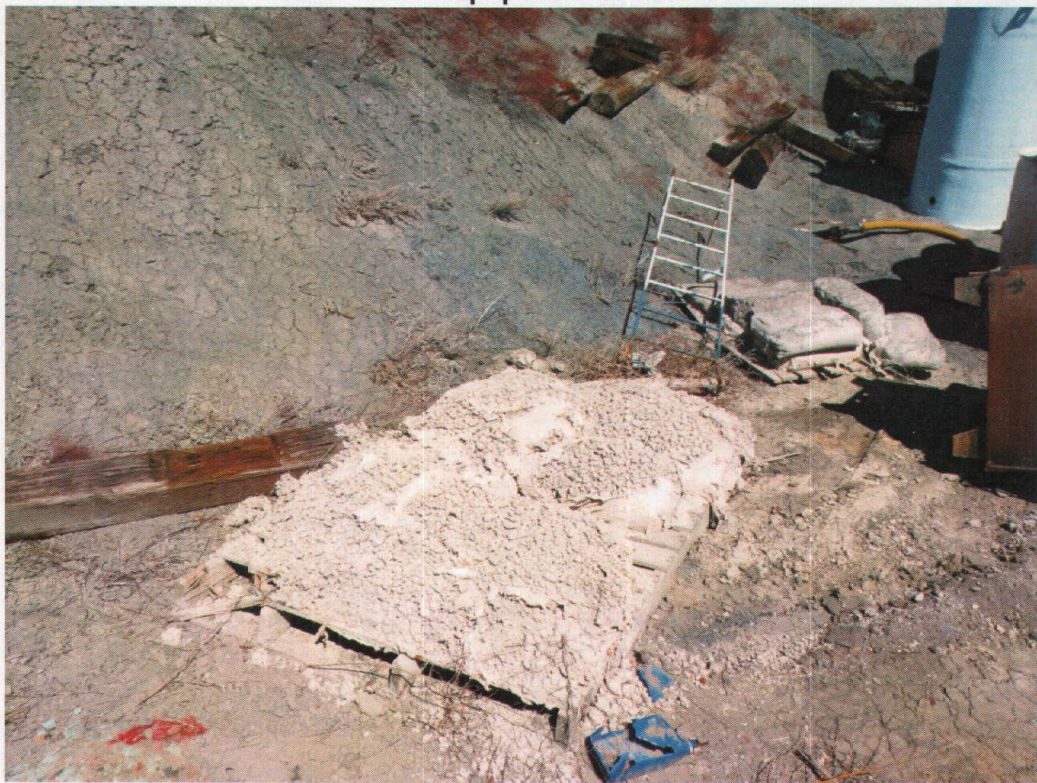
**Bags that have Split Open and Been Exposed to Weather**

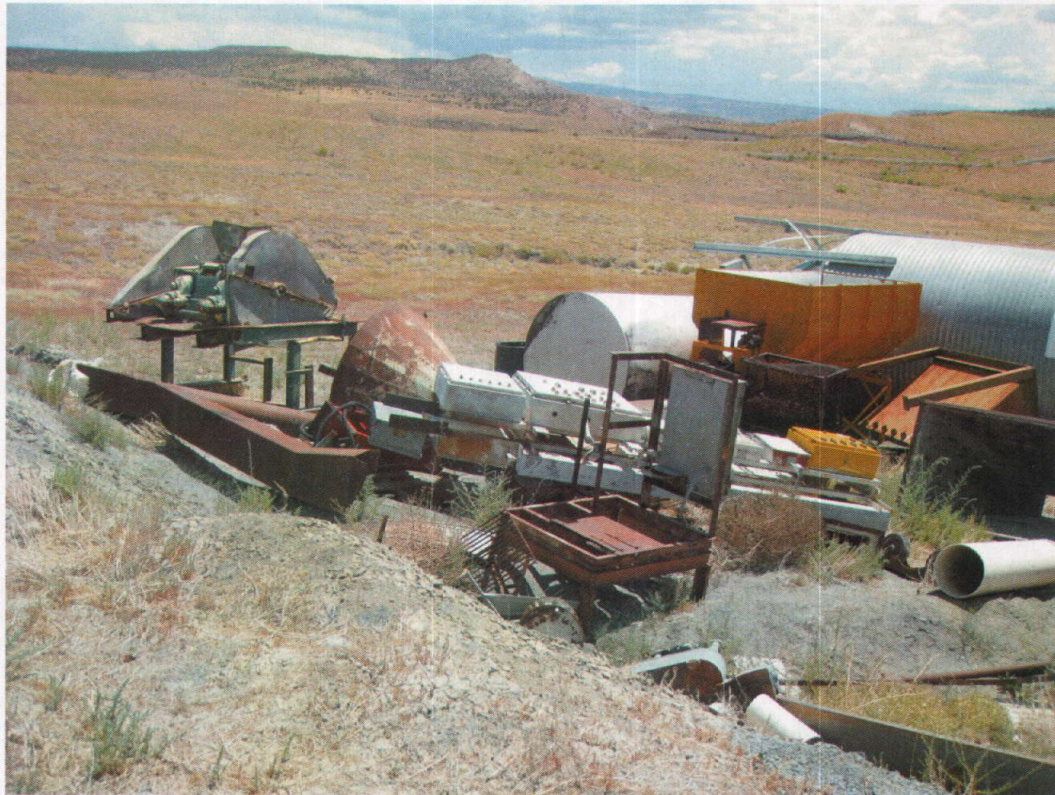
**Misc. Equipment at Site and Not in Use**

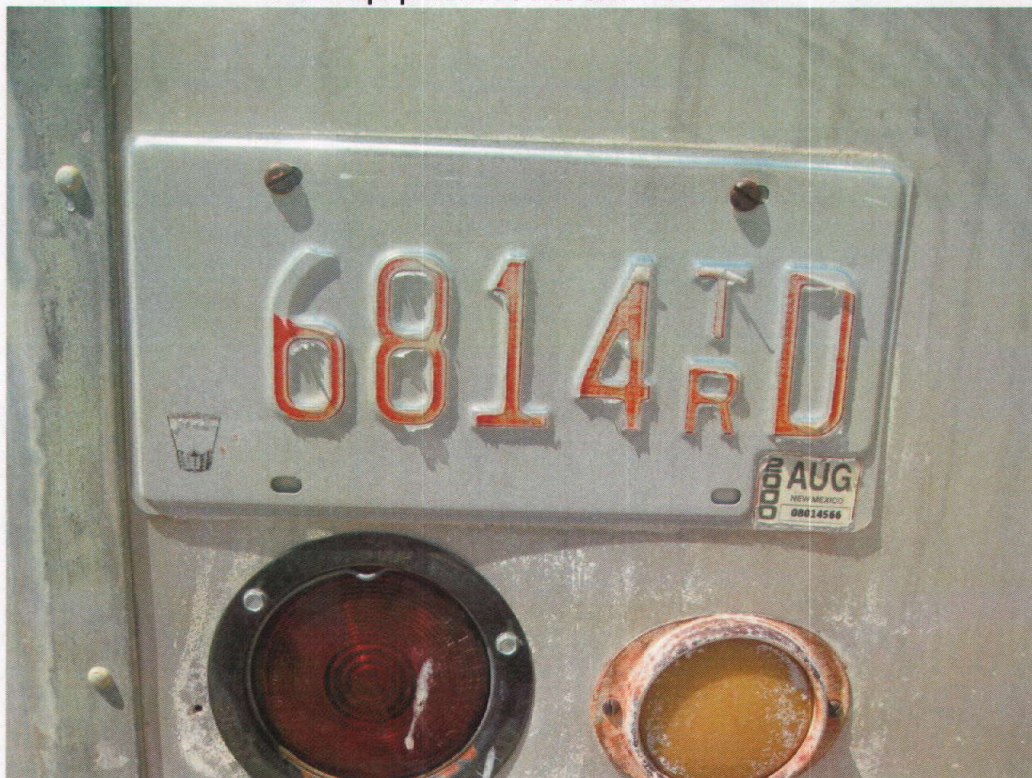
**Expired Plates from Storage Trailer (11 Years)**

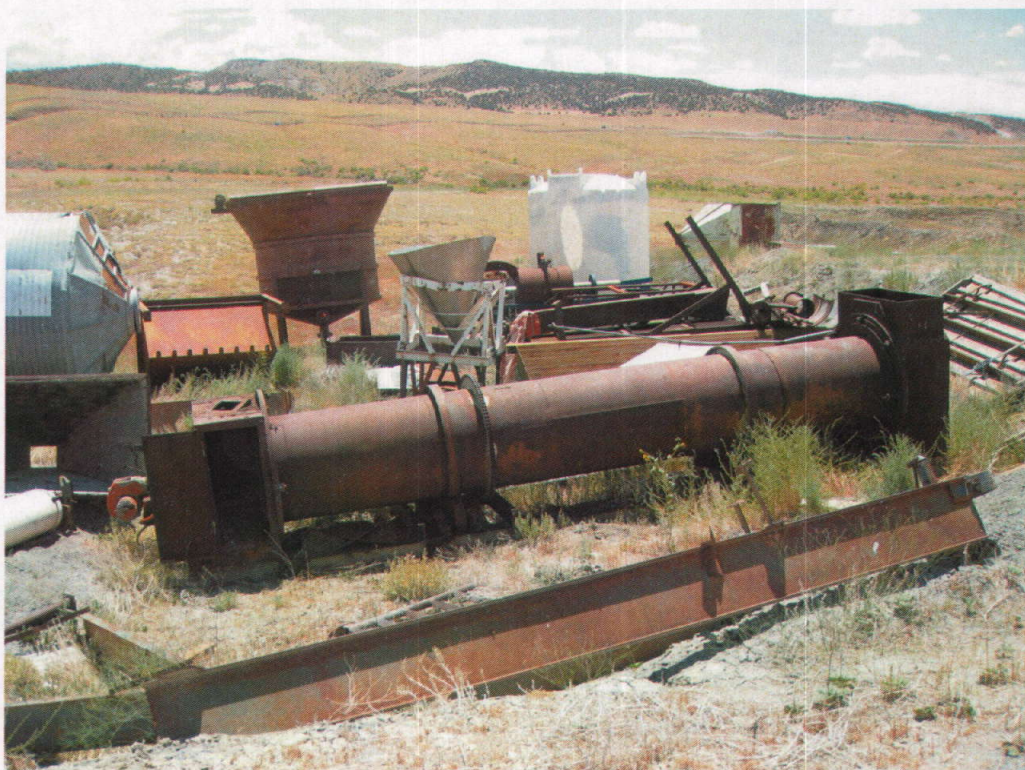
**Misc. Equipment at Site**

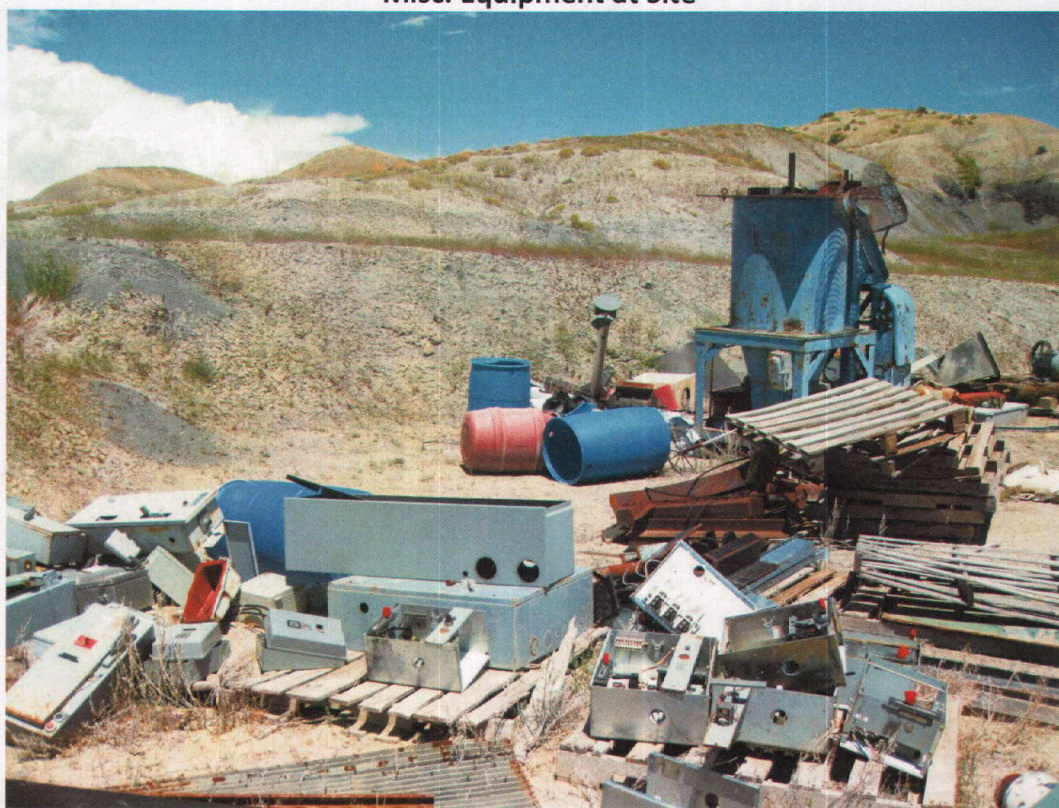
**Misc. Surface Debris**

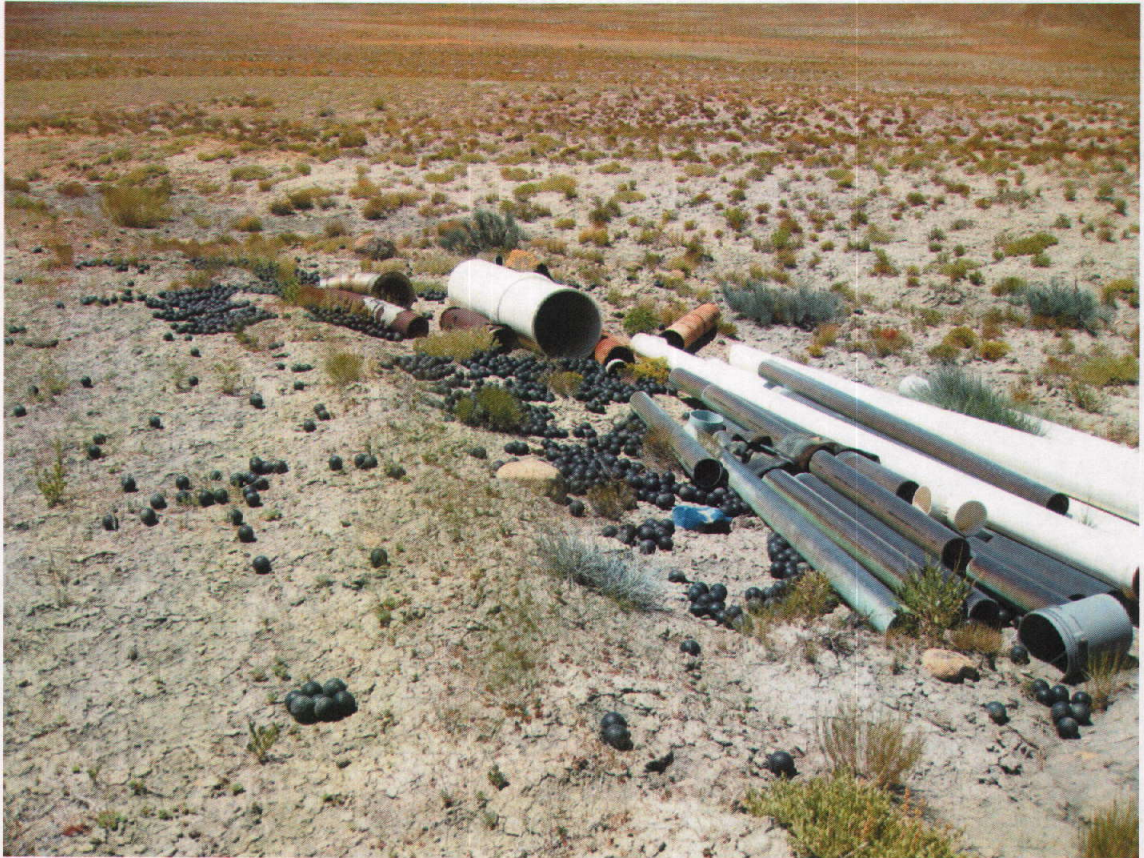
**Misc. Surface Debris**

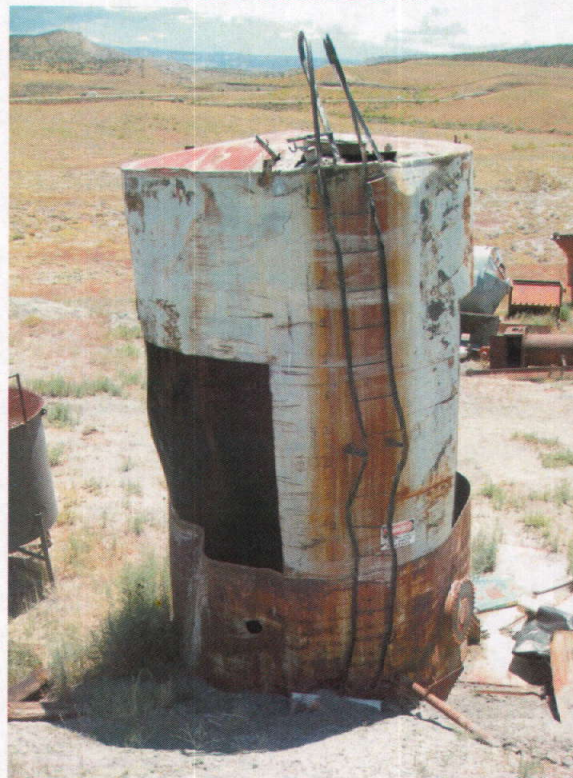
**Surface Debris**
